TG-701 GROUND FAULT RECTIFICATION

Introduction

Fauji Fertilizer Company Limited has two Urea plants near Sadiqabad, Pakistan. Electrical power source to this ammonia-urea complex, are two Gas Turbines TG-701 & TG-702, serving relentlessly as a backbone of the plants for the past 30 years. MARK-II is installed on TG-701. TG-701 turbine has had Speedtronic and 125VDC power supply ground faults since 2003. These ground faults caused many mysterious outages on the turbine. History data analysis reveals at least one tripping or emergency shutdown each year that can be attributed to these ground faults. Attempts for the detection and rectification of these ground faults were made in several turnarounds with no success. This year in plant turnaround Oct-2009, this long awaited target was accomplished.

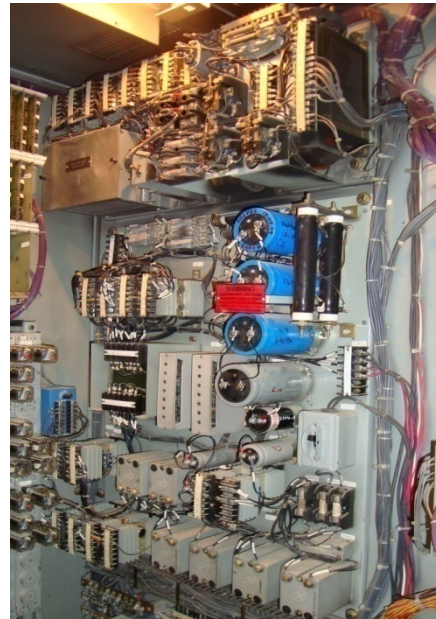
Fig4: Bulk Power Supply Module

Power Supply Module: Bulk power supply module was overhauled in electrical shop. Its power switching cards EPSU and EPSV were found in bad condition covered with carbon dust. These cards were cleaned, checked and re-installed. One capacitor was replaced as it was showing zero microfarads.

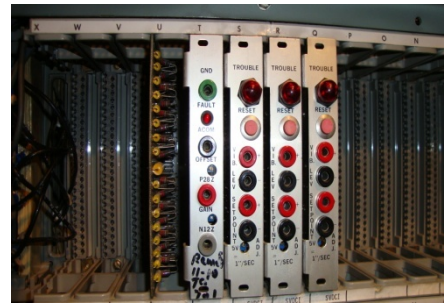
Fig14: SGDD Card Indication Reset

To conclude the grounded part, 96FG was disconnected from the area JB while -12VDC still connected to main bus bar. SGDD card indication remained reset. The situation was verified several times.

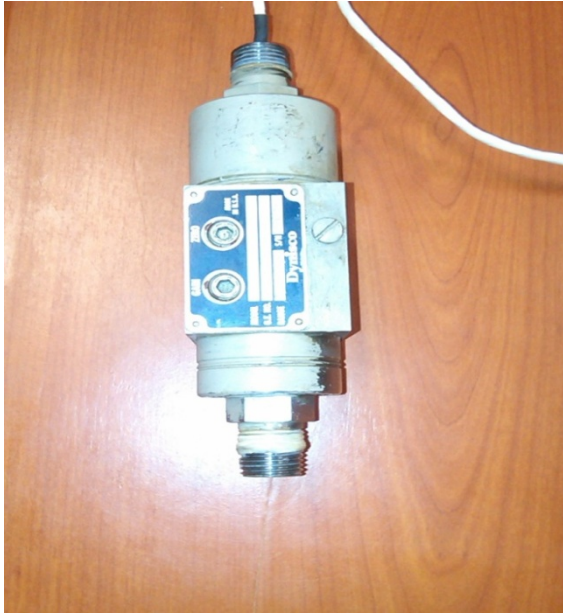
Fig14: Faulty Fuel Gas Transmitter 96FG

New transmitter 96FG was installed in the area. During a thorough examination of faulty 96FG in the workshop the black signal cable of 96FG was found showing only 1.7Ω resistance with ground. The Ground Fault persisted even when the suspected cable was de-soldered from the PCB board. Finally, it was concluded that the signal terminal and ground terminal of PCB board of 96FG were short.

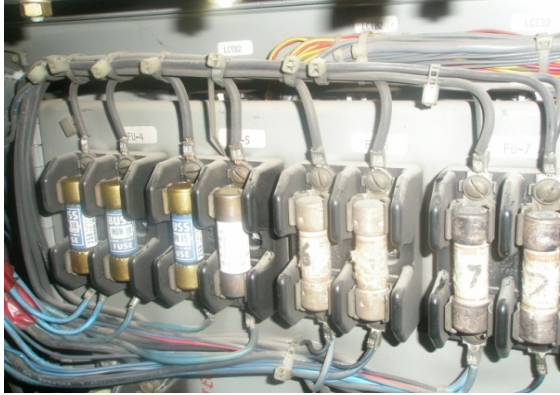
Fig16: 125VDC Fuses

During one of its random appearances the Ground Detector Relay 64D remained actuated for some time. Immediately, all the fuses were pulled out one by one starting from FU-7. The ground fault normalized as soon as FU-4 negative supply fuse was pulled out. The grounding appeared again immediately after the re-installation of the fuse FU-4.

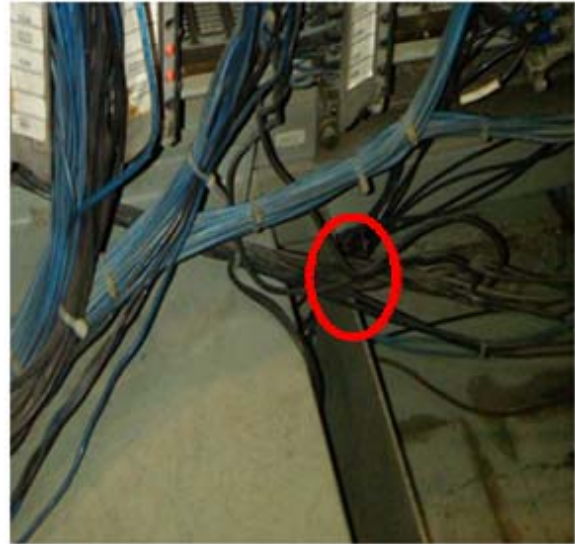
The 125VDC ground fault was finally found in the cables entering the MARK-II cabinet from bottom. These cables were routed over a channel support. On the top of these cable was a horizontally bolted plate. These cables were pinched in between the support and the top metal cover plate. Any weight / load on the upper plate would press these cables against the sharp edges of support.

Fig17: Top plate taken aside to see the cables over the vertically mounted support

The cables were then insulated, protected and properly routed to their respective locations. The cables which were not being used in the

system were separated and adequately secured for future use.

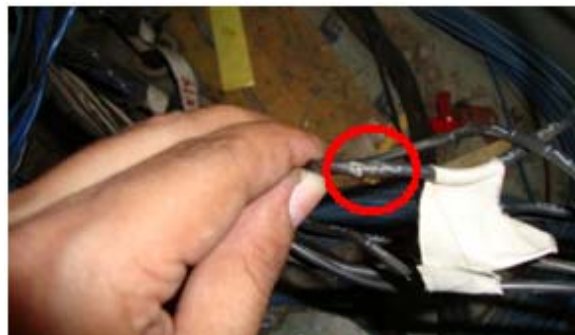
Two out of seven pairs of this cable were in use. One of the cores had a major cut while others had minor cuts.

Fig18: Cut on the Grounded Cable
