TG-701 GROUND FAULT RECTIFICATION

Introduction

Fauji Fertilizer Company Limited has two Urea plants near Sadiqabad, Pakistan. Electrical power source to this ammonia-urea complex, are two Gas Turbines TG-701 & TG-702, serving relentlessly as a backbone of the plants for the past 30 years. MARK-II is installed on TG-701. TG-701 turbine has had Speedtronic and 125VDC power supply ground faults since 2003. These ground faults caused many mysterious outages on the turbine. History data analysis reveals at least one tripping or emergency shutdown each year that can be attributed to these ground faults. Attempts for the detection and rectification of these ground faults were made in several turnarounds with no success. This year in plant turnaround Oct-2009, this long awaited target was accomplished.

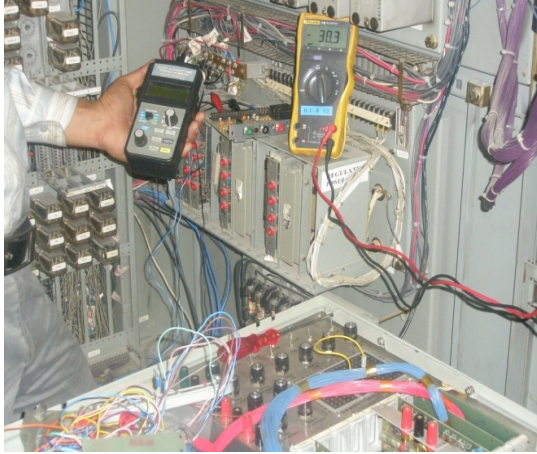
Fig9: Speedtronic Calibration Setup

Calibration of different controls and protection loops was performed. Checking & calibration of power supply, Speed control loop, acceleration control loop, temperature control loop, PCD bias adjustment, over-temperature, speed protection and start-up control was performed.

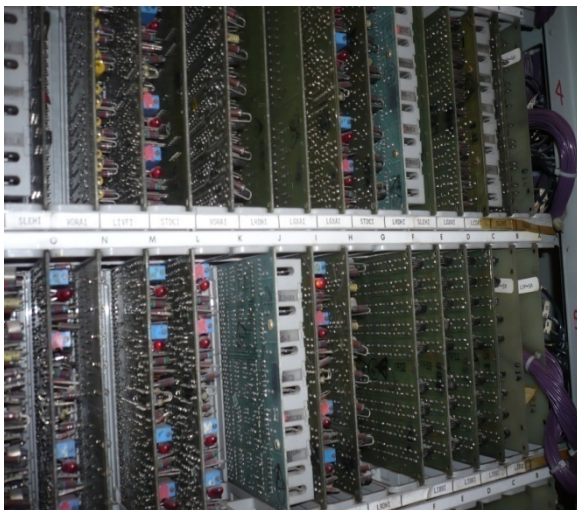
Fig10: 1L Page Cards

All 126 cards on Speedtronic 1L page were pulled out one by one. Each card has 51 pins. Ground fault indication kept persisting till the last card was pulled out.

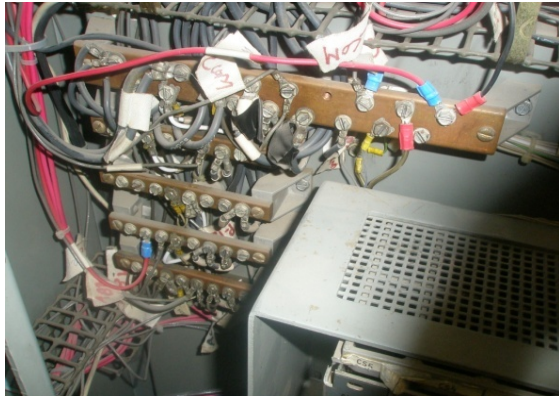
Fig12: Main Bus Bars of 28VDC, +12, -12, +5 & COM

Once the card was functioning all the power distribution cables of regulated supplies 28VDC, 12VDC, -12VDC, 5VDC, PCOM, ACOM, DCOM

were disconnected one by one from the main bus bar.

In the above step REMAN module, Local annunciator module, thermocouple processing module and synchronizer module were disconnected. SGDD ground fault indication still persisted. A total of 235 cables were removed while isolating all above modules from Main Bus and their respective Terminal Blocks.

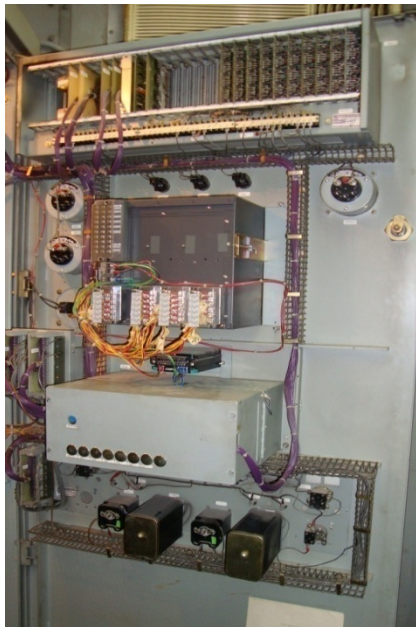
Fig13: Thermocouple Module & Annunciator

After disconnecting about 50 more cables we found the suspected cable on -12VDC distribution circuit. The cable was physically
